LANE COVE TUNNEL

COLLAPSE AND SUBSIDENCE

REPORT - 2 NOVEMBER 2005

**LANE COVE TUNNEL COLLAPSE AND
SUBSIDENCE**

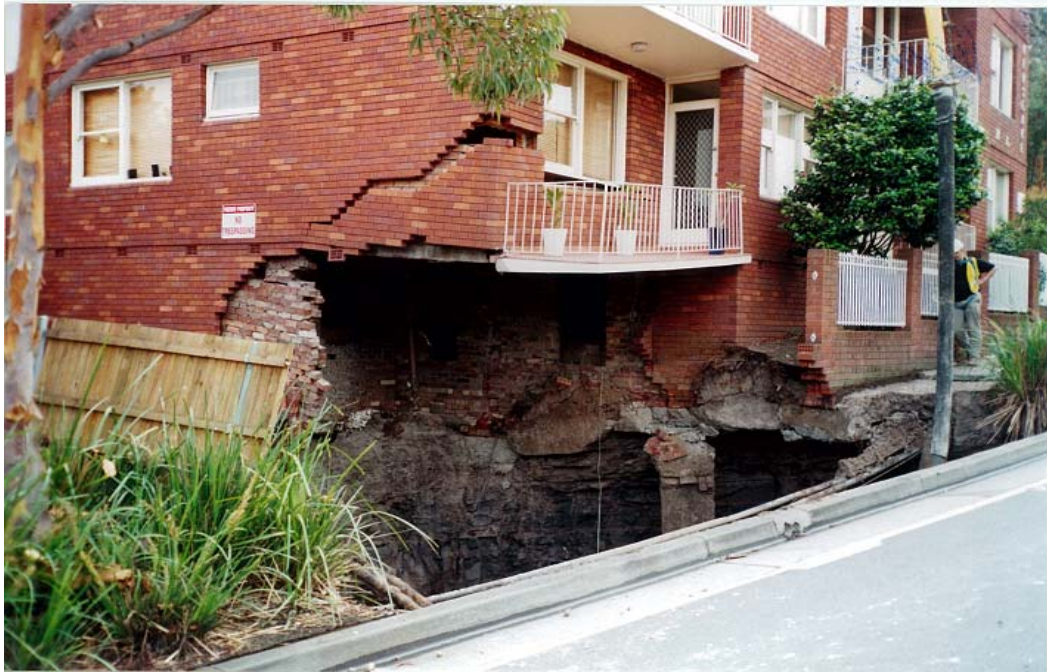
1.12 The collapse led to a significant ground subsidence that affected the stability of a block of home units situated at 11-13 Longueville Road, Lane Cove.¹ There were also concerns relating to a retaining wall that

Damage to the unit block at 11-13 Longueville Road, Lane Cove **Plate 1**

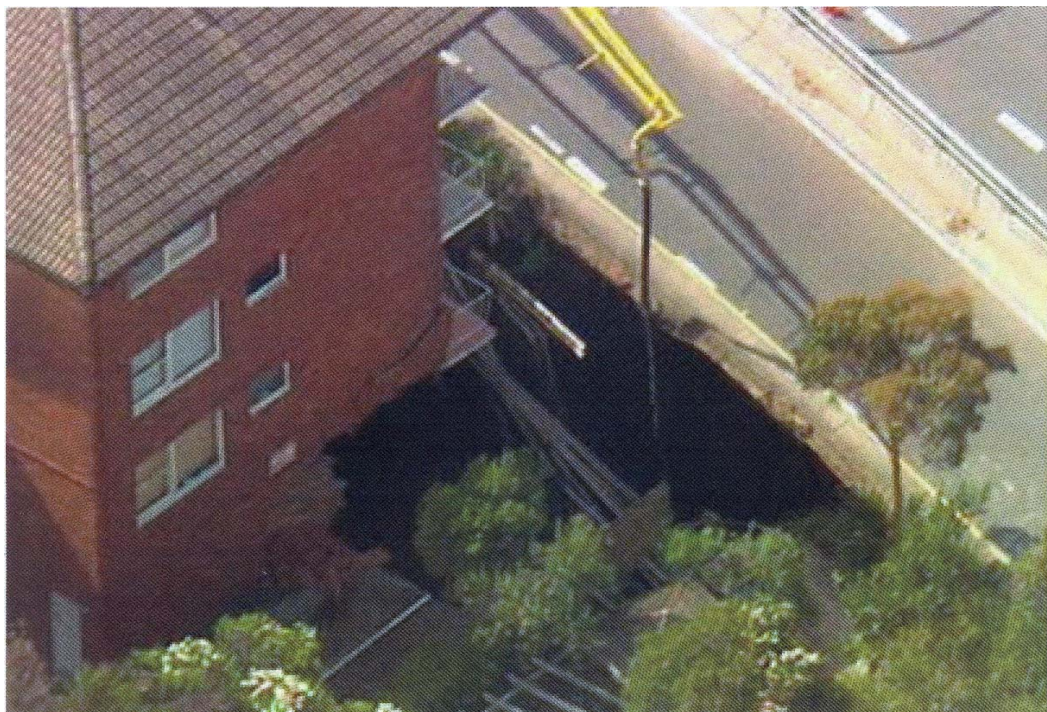
Looking down on the south western corner of Kerslake Apartments, 11-13 Longueville Road, 2 November 2005 **Plate 2**

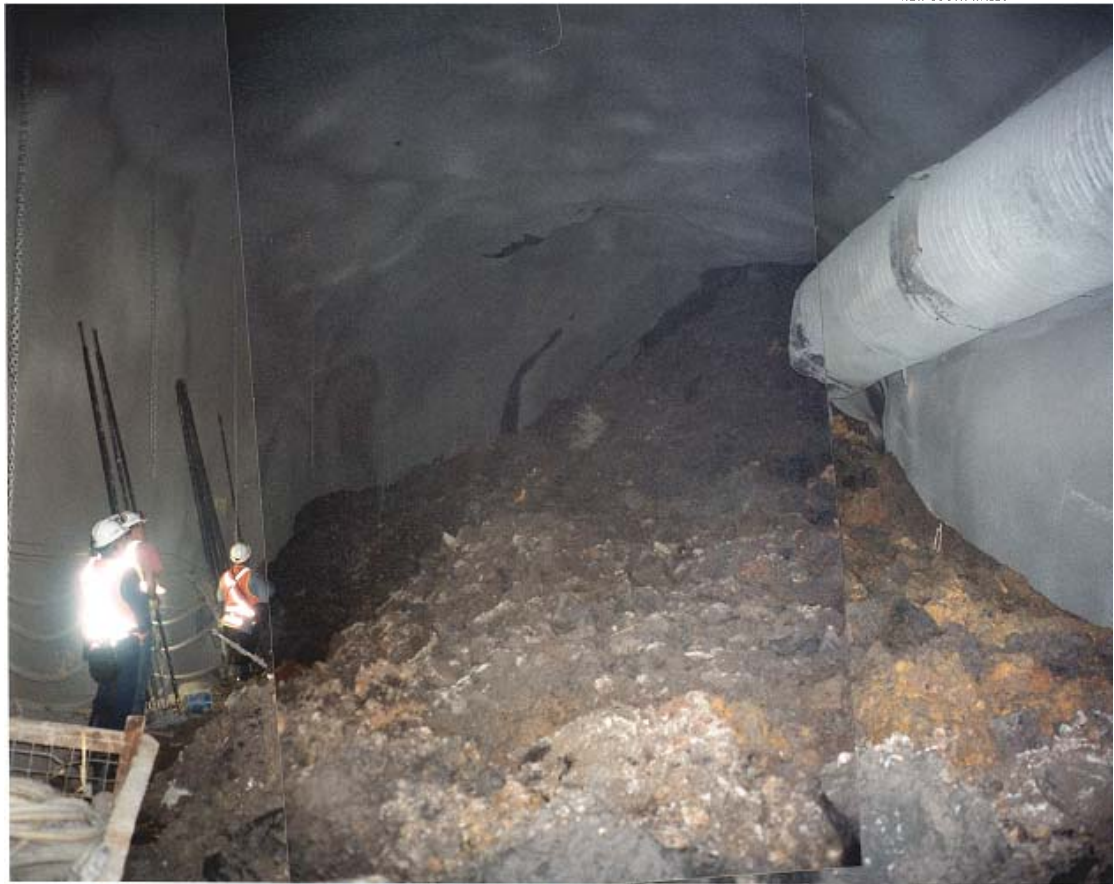
- 2.8 Staff considered that the collapsed debris required strengthening before any surface activity could occur.⁶ It was proposed to place large diameter hammered rock to form a bridging layer to lessen any pressure on the pile of collapsed debris. However, the need to remove an electrical sub-station and a dust scrubber from the area before the rock could be placed up against the debris pile delayed this action. This strategy was discarded as observation of the hole at appropriately 5:30am revealed the hole had expanded in size. At about 6:00am loud noises were heard to be coming from the hole and it was observed that a substantial secondary collapse had occurred under the existing Longueville Rd exit ramp and a number of piles with the collapsed area of the tunnel were observed to have been undermined by the collapse. The hole at that stage was observed to be around 8-9m diameter.

Collapse debris in MC5B ventilation Tunnel, 3rd November 2005 **Plate 3**

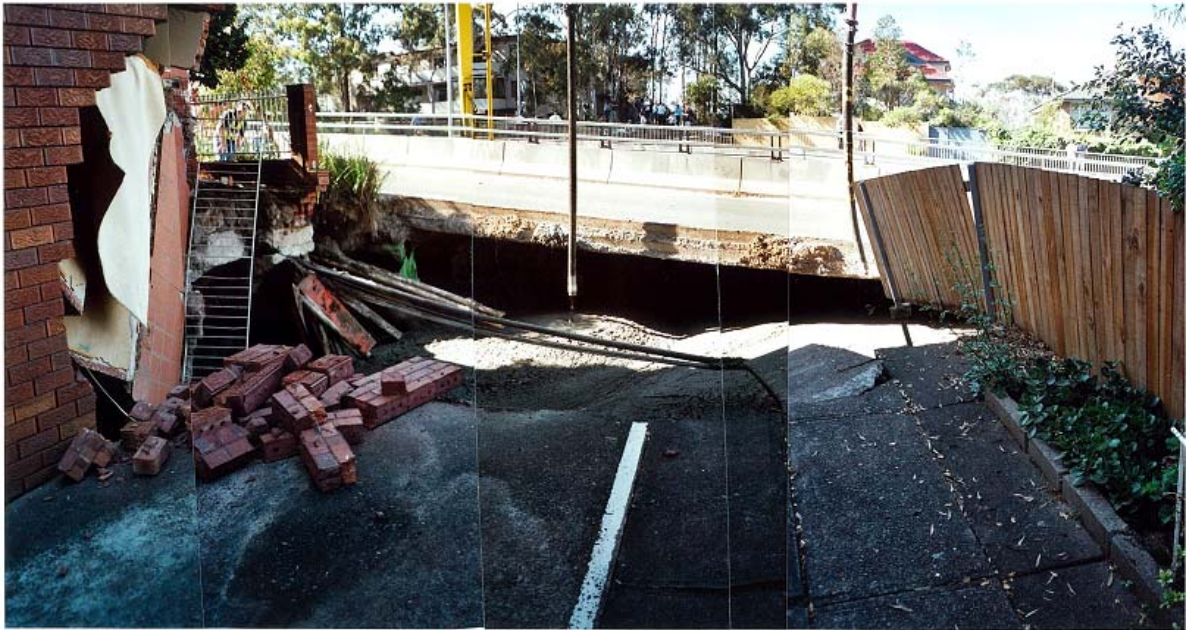
Pacific Highway Off-Ramp and south western corner of Kerslake Apartments. Void backfilling with concrete 3rd November 2005 **Plate 4**

- 2.9 It was at this stage that the decision was made by TJH to commence filling the hole with concrete to mitigate any further collapse. Concrete pumping commenced with one pump at approximately 8am. Two further concrete pumps arrived shortly after and also commenced pouring, the initial pour ceasing at around 3:00pm, having reached a height of 2 metres above the top of the pile. This amount of concrete had been determined as the maximum that could be placed initially without putting pressure on the exit ramp retaining wall. Longueville Road had been closed to traffic at approximately 6:45 am.

- 2.10 After waiting for the first lot of concrete to cure a second pour was commenced at approximately 9:30pm on 2 November 2005 and completed at around 12:30am the following morning. The third and final concrete pour, which was to reach the level of the top of the retaining wall, was commenced at 6:30am on 3 November 2005 and completed mid-morning.⁷ Over the next couple of days, grout was pumped into identified void areas around the collapse to complete the stabilisation works. In total, approximately 2750 cubic metres of concrete and grout was pumped into the collapsed area.
