December 19, 2014

Re: SR 99: Shaft Excavation Status Report & Action Items for Discussion
TBM Access Shaft, Seattle, WA

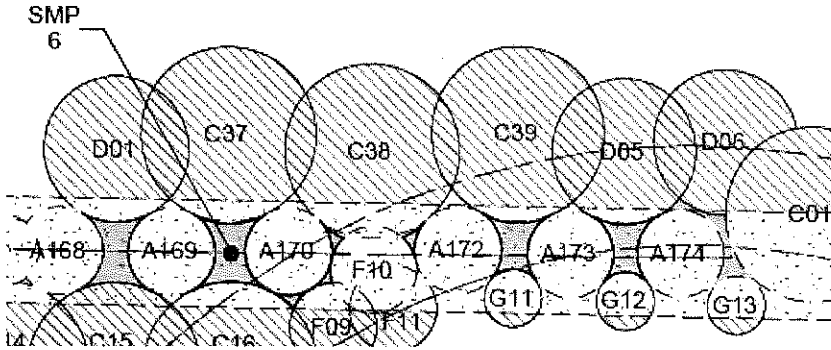
Figure 1: West Shaft Wall Design In-Fill Areas (Solid Gray Shaded Areas)

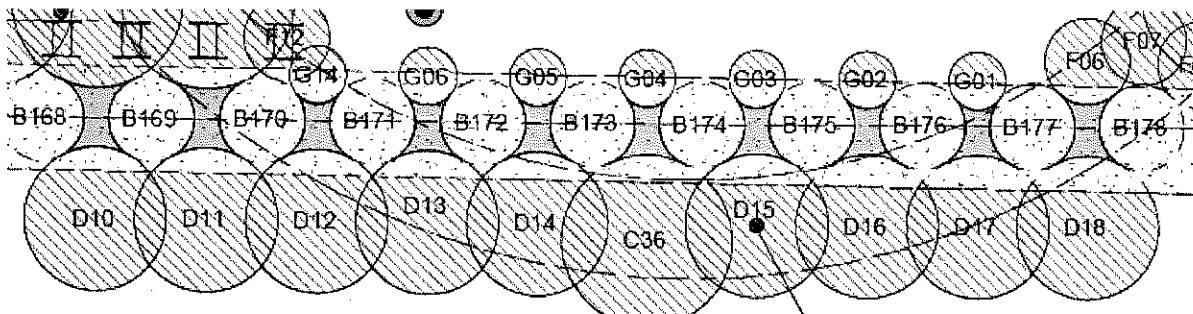
Figure 2: East Shaft Wall Design In-Fill Areas (Solid Gray Shaded Areas)

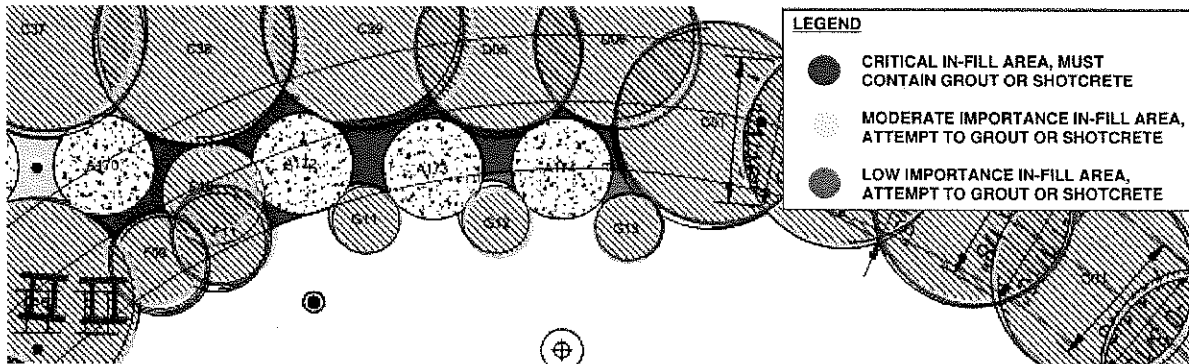
Upon review of the as-built secant pile locations with respect to the SESMP piles, there appears to be a potential for much larger in-fill areas than initially intended in the design. Given the observed untreated soil zones in the in-fill areas to date, the as-built pile layouts shown in Figure 3 and Figure 4 indicate the extent of potential untreated zones in the colored areas. Potentially untreated soil zones that fall within the theoretical design compression ring and may have a significant effect on the stability of the shaft structure are shaded red. A continuous compression ring of adequate thickness and strength is essential for the structural stability of the wall.

Figure 3: West Shaft Wall Pile As-built (Potential Void Areas Highlighted in Yellow or Hatched)

While it is likely the in-fill areas are larger than initially intended, we do not believe they are as extensive as shown in the as-built pile layouts of Figure 3 and Figure 4. For example, Figure 4 shows the potential for a nearly continuous void through the entire width of the shaft wall between piles B177/F06 and B178/D18. However, if this were the case, we believe that significant seepage and ground loss would have been observed during the course of excavation to date. Given the rate of seepage observed and the lack of ground loss outside the shaft, it is likely there is some continuous wall present between piles B177/F06 and B178/D18.

The source of the uncertainty for the as-built condition is the lack of as-built data for the SESMP piles. Once the as-built of the SESMP piles is incorporated into the existing overall shaft as-built drawings, a more refined analysis of the ring-structure can be completed and critical in-fill repair locations identified.

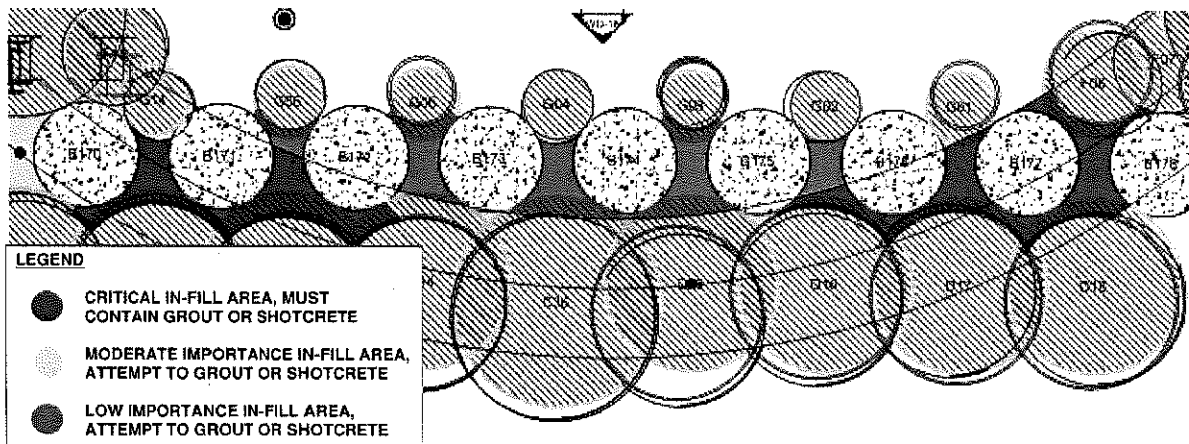
Figure 4: East Shaft Wall Pile As-built (Potential Void Areas Highlighted in Yellow or Hatched)
