December 11, 2014

Re: SR 99: Shaft Excavation Status Report & Action Items for Discussion
TBM Access Shaft, Seattle, WA

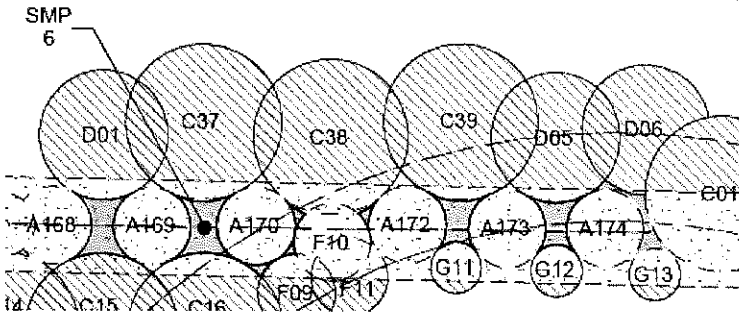
Figure 1: West Shaft Wall Design In-Fill Areas (Solid Gray Shaded Areas)

Reviewing the as-built locations of the shaft piles at regular vertical intervals, we are concerned that there is a potential for much larger untreated soil zones to exist than initially considered in the design, depending on the location of the SESMP piles. The design pile layouts shown in Figure 1 and Figure 2 indicate the originally expected in-fill or void areas in solid gray.

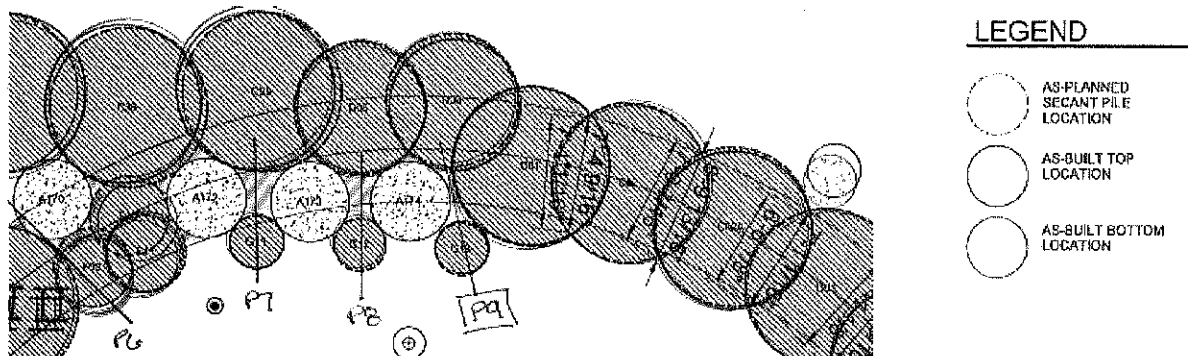
Figure 3: West Shaft Wall Pile As-built (Potential Void Areas Highlighted in Yellow or Hatched)

Upon review of the as-built secant pile locations with respect to the SESMP piles, there appears to be a potential for much larger in-fill areas than initially intended in the design. Given the observed untreated soil zones in the in-fill areas to date, the as-built pile layouts shown in Figure 3 and Figure 4 indicate the extent of potential untreated areas in yellow. Potentially untreated soil zones that fall within the theoretical design compression ring. A continuous compression ring of adequate thickness and strength is essential for the structural stability of the wall.

While it is likely the in-fill areas and associated untreated soil zones are larger than initially intended, we do not believe they are as extensive as shown in the as-built pile layouts of Figure 3 and Figure 4. For example, Figure 4 shows the potential for a nearly continuous void through the entire width of the shaft wall between piles B177/F06 and B178/D18. However, if this were the case, we believe that significant seepage and ground loss would have been observed during the course of excavation to date. Given the rate of seepage observed and the lack of ground loss outside the shaft, it is likely there is some continuous wall present between piles B177/F06 and B178/D18.

The source of the uncertainty for the as-built condition is the lack of as-built data for the SESMP piles. Once the as-built of the SESMP piles is incorporated into the existing overall shaft as-built, a more refined analysis of the ring-structure can be completed and critical in-fill repair locations identified.
